Plant Examples of Potential Failure Mechanisms (Not all real)

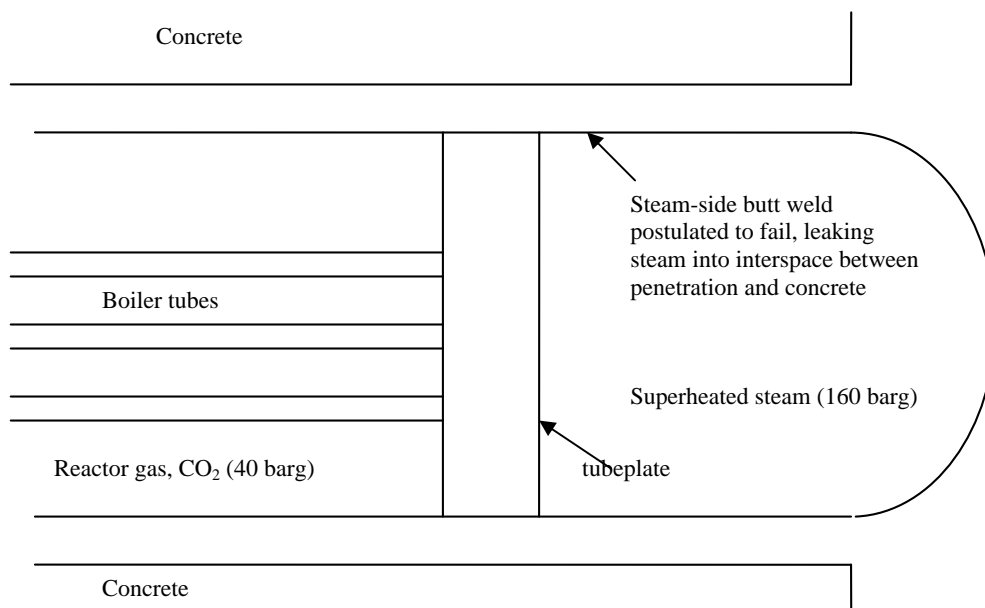
DNB Penetration for Qu.[7]

- [7] DNB superheater penetration under fault conditions such that the penetration-concrete interspace becomes pressurised by escaping steam (see G/A). What mechanism might be of concern as regards potential gas-side failure?
